PHASE ONE
SITE CHARACTERIZATION REPORT

BUREAU OF INDIAN AFFAIRS
ROAD SHOP FACILITY
DUCK VALLEY INDIAN RESERVATION
OWYHEE, ELKO COUNTY, NEVADA

November 3, 1999
SECOR Job # 093.99052.003

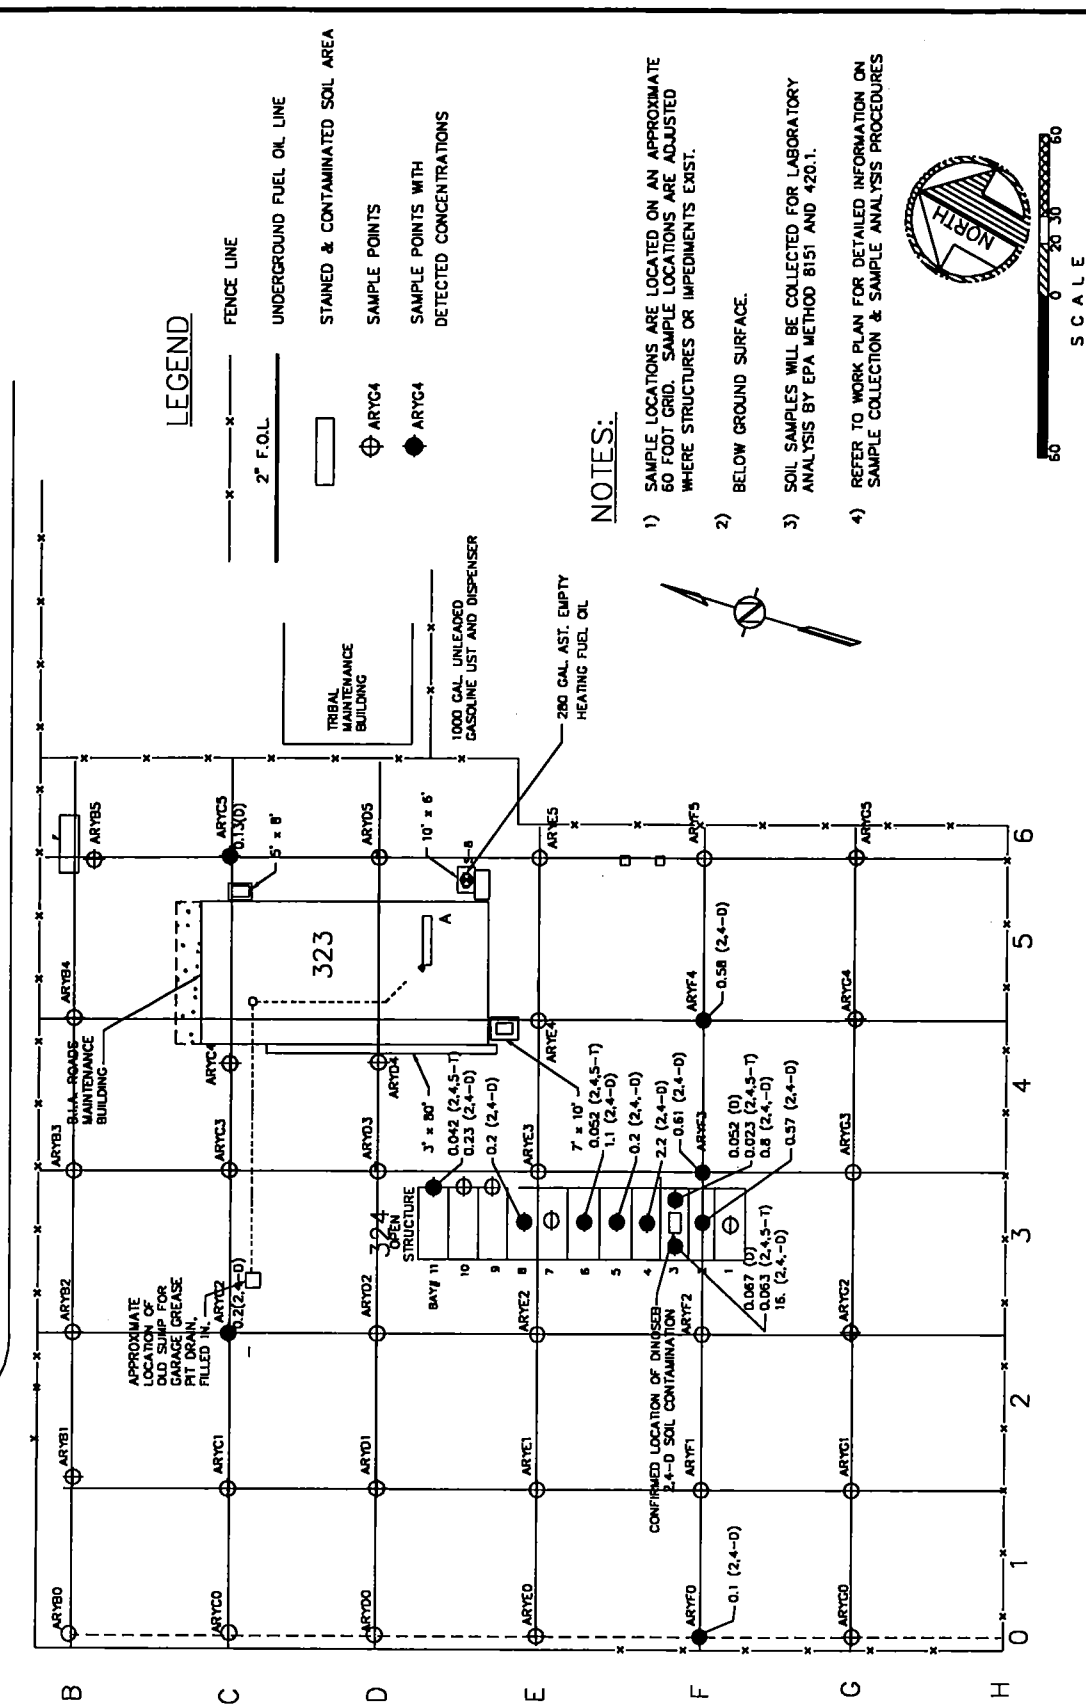
FIGURE 2
Site Map with Soil Sampling Results

On June 9, 1999, test pit excavations were being sampled at the Yard in Bay #3 of the open storage structure (Building #324) located in the central portion of the site (*Figure 2*). During these activities, yellow stained soil with a strong odor was identified and sampled. Local personnel with knowledge of the site suggested that the soil might contain herbicides. Based on that information, the Yard was secured and access was limited. A sample of the soil was collected and sent for analysis to Alpha Analytical, Inc., a Nevada certified laboratory. Laboratory analytical results were received on June 14, 1999, indicating that the soil contained 2,4-D and Dinoseb in concentrations of 700 mg/kg each.

A total of 39 composite soil samples along the open yard grid were collected and analyzed for Dinoseb, 2,4-D, and 2,4,5-T. Five of these composite samples contained detectable amounts of either Dinoseb (ARYC5) or 2,4-D (ARYC2, ARYF1, ARYF3, and ARYF4) in relatively low concentrations (0.13 mg/kg and less than 0.7 mg/kg, respectively). Sample locations ARYF3 and ARYF4 are located outside (to the east of) the entrance to Bays #1, #2, and #3. **Figure 2** provides the sample locations where these compounds were detected.

The occurrence of Dinoseb and 2,4-D in the open Yard was in relatively low concentrations and was limited to three isolated sample locations (ARYC2, ARYC5, and ARYF0) and two sample locations (ARYF3 and ARYF4) in front of the entrances to the bays near the apparent source of the contamination (Bay #3).

The soil analytical results from open Yard samples collected in the areas where Dinoseb-contaminated soils were stockpiled were all below instrument quantitation limit, indicating that removal of the stockpiles was complete, with no evidence of residual contaminated soil left behind.

Although the isolated occurrences of COCs in the Road Shop Yard appear to be residual and do not, by themselves, present a risk to human health, the vertical extent of these occurrences has been delineated only to a depth of less than one foot (except in Bay #3 where 18 to 20 inches of contaminated soil was excavated). While the likelihood of higher concentrations being discovered below one foot of depth is low, there remains uncertainty in that regard. Therefore, SECOR recommends that the following actions be taken to address the remaining uncertainty regarding vertical extent of residual contamination:

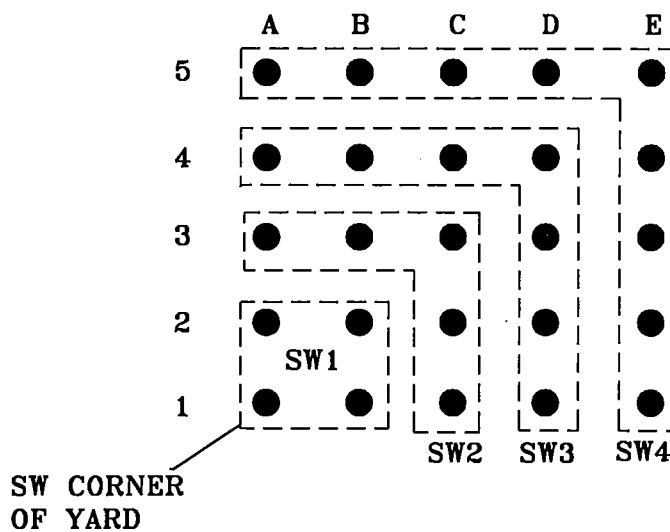
FIGURE: 3
DATE: 10/15/99
PROJECT NO: 093.50350.003

Southwest Corner of the Yard: Concentrated sampling was conducted in the far southwest corner of the Road Shop Yard due to suspected past activities involving mixing and/or storage of chemical compounds in that area. Figure 3 provides the sampling layout for the southwest corner of the Yard. None of the soil samples collected from the southwest corner contained detectable amounts of Dinoseb, 2,4-D, or 2,4,5-T.

SAMPLING PLAN
SOUTHWEST CORNER DUMPING AREA
ROADS SHOP YARD
DUCK VALLEY RESERVATION, OWYHEE, NEVADA

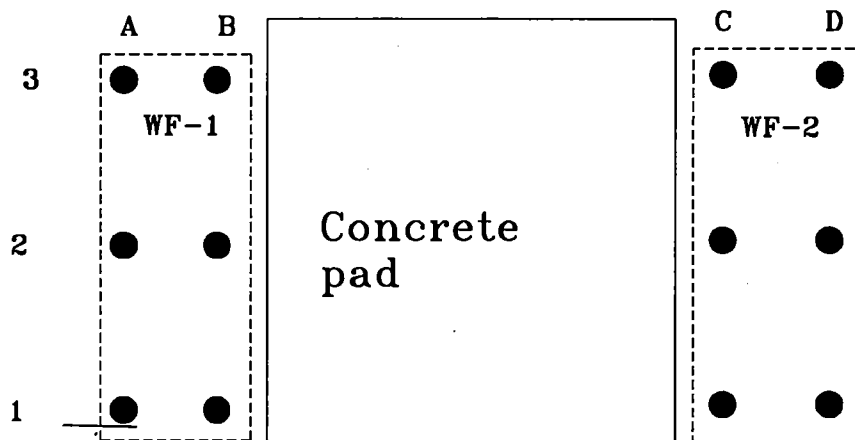
FIGURE: 4
DATE: 10/15/99
PROJECT NO: 093.50350.003

North End of the Maintenance Building: Concentrated sampling was also conducted at the entrance to the (north end of) the BIA Road Shop Maintenance Building #323. This area was reportedly used for mixing of chemical compounds in the past, facilitated by the presence of a water faucet on the north wall of the building. Figure 4 provides the sampling layout for the north end of the Maintenance Building. None of the soil samples collected from this area contained detectable amounts Dinoseb, 2,4-D, or 2,4,5-T.

SAMPLING PLAN
NORTH END OF MAINTENANCE BLDG.
ROADS SHOP YARD
DUCK VALLEY RESERVATION, OWYHEE, NEVADA

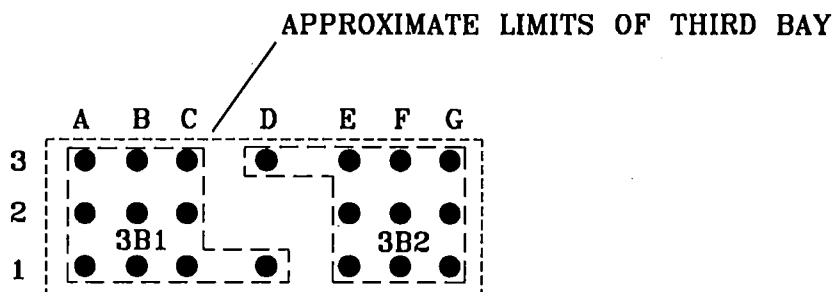
Concentrated sampling grids were established in three separate areas of the Yard where COCs were suspected of having been handled in the past. These areas were (1) the far southwest corner of the Yard (*Figure 3*); (2) at the north end of the Maintenance Building #323 (*Figure 4*); and (3) inside Bay #3 of the open storage structure #324 (*Figure 5*), where the Dinoseb was initially discovered.

Bay #3 was a confirmed source of Dinoseb contamination. Soil with visible signs of Dinoseb contamination (yellow coloration) in Bay #3 was excavated and removed, contained, and subsequently incinerated. Two composite samples were then collected from Bay #3.

Low concentrations of Dinoseb (less than 0.1 mg/kg) were detected in both of the composite soil samples from Bay #3. However, Dinoseb was not detected in any of the other bays. Chemical compounds 2,4-D and 2,4,5-T were detected at low concentrations (less than 17 mg/kg and less than 0.07 mg/kg, respectively) in Bays #3, #6 and #11. Lone amounts of 2,4-D (less than 3 mg/kg) were detected in Bays #2, #4, #5, and #8. Table 1 presents the analytical results from soil samples within the Open Storage bays.
